The creeping shores of the Golden Horn

KEYWORDS: Pore pressure dissipation, creep, slope stability

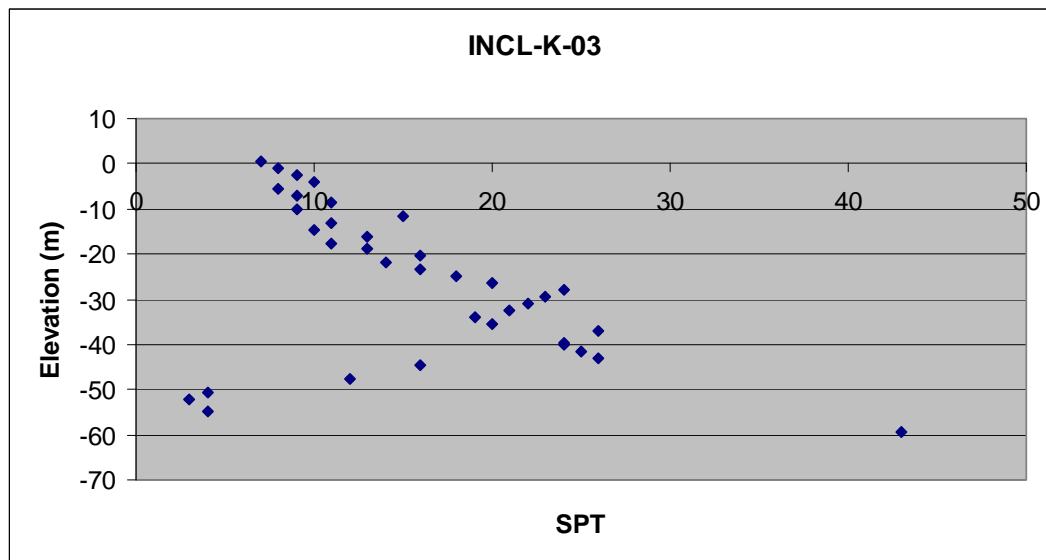
Soft clay layers at inclinometer locations with very low SPT blow counts at greater depths are discernible in Figures 1 to 4.

Figure 1. Inclinometer locations with SPT blow counts – INCL-K-03

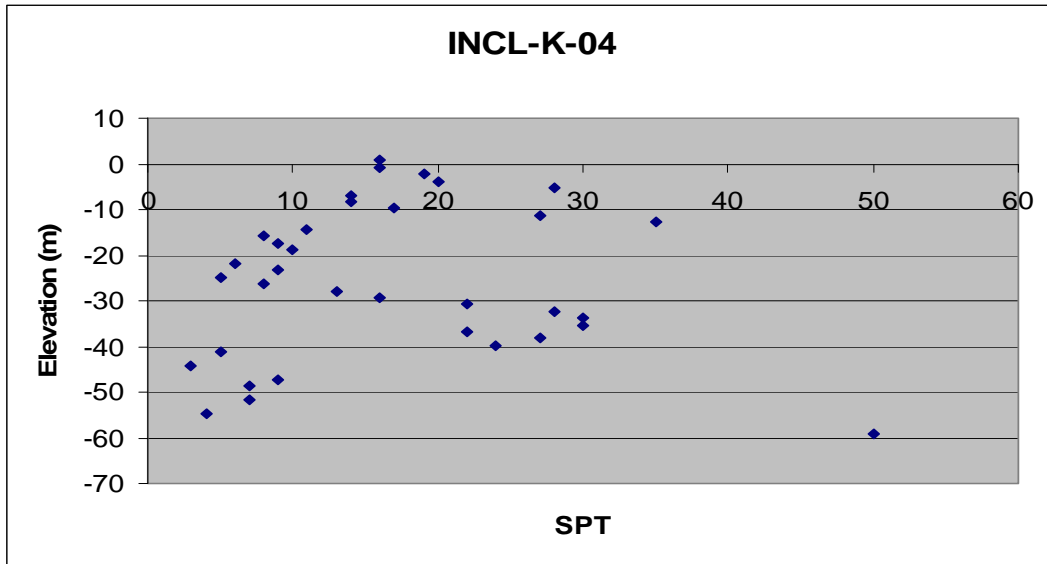
Figure 2. Inclinator locations with SPT blow counts – INCL-K-04

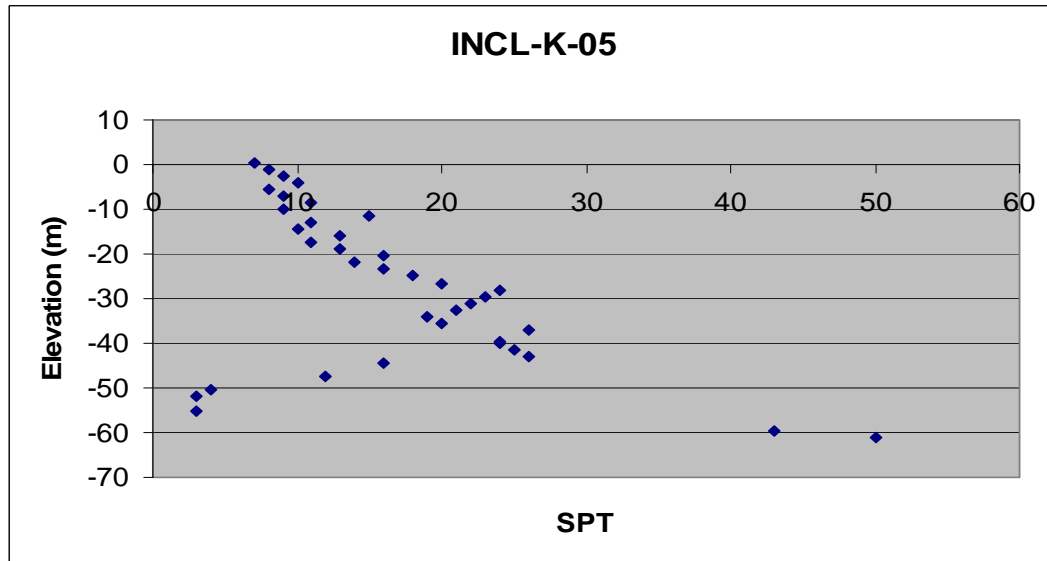
Figure 3. Inclinator locations with SPT blow counts – INCL-K-05

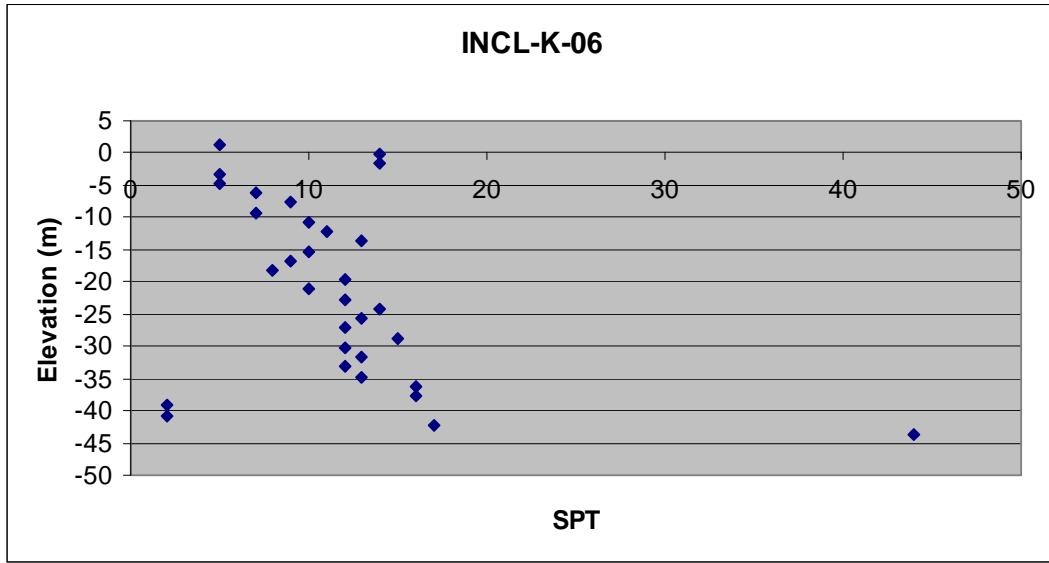
Figure 4. Inclinometer locations with SPT blow counts – INCL-K-06
