Settlement observations of industrial structures founded on soft soils: case of the harbour zone of Bejaia city

ABSTRACT: This paper presents and discusses the settlement observations of two industrial structures located on the harbor zone of Bejaia. It consists of a cylindrical steel tank and a battery of ten steel silos. The tanks were founded on a reconstituted and compacted granular fill. The silos were founded on a flexible raft foundation anchored on reinforced soil by stone columns. Due to the high compressibility of the soft soil deposits underlying the area, the foundations of these structures were subjected to excessive settlements, prejudicial to their stability. For the tanks, micropiles are used for underpinning and retrofit of existing foundations.

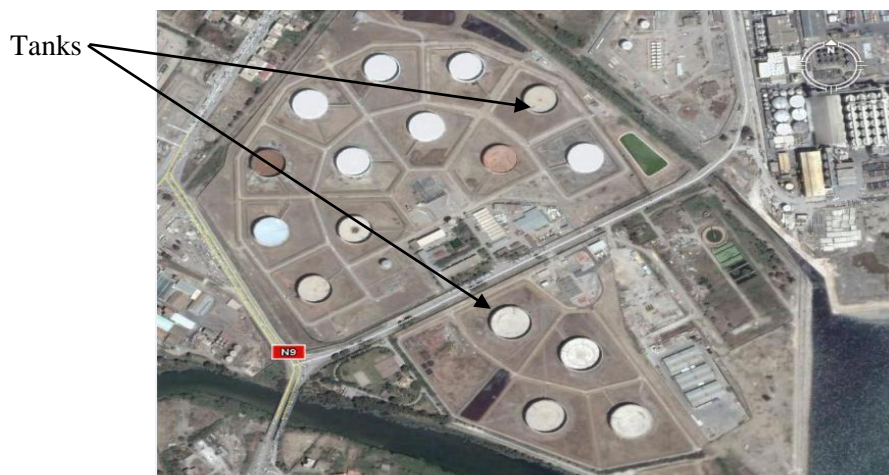
Figure 1. Tank locations.

The marine terminal of Bejaia is a zone of storage of hydrocarbon liquids. It consists of sixteen cylindrical floating roof steel tanks (Figure 1). The tanks range in capacity from 30 000 to 50 000 m³ with varying diameter ranging from 56 m to 67 m. All the tanks had a height of 16 m. The tanks were built in 1957. Their structure consists of an assemblage of metallic shells of varying thickness from 8 to 32 mm welded to a flexible foundation made of metallic sheets of 12 mm thick. Inside them slides a steel floating roof weighting approximately 430 tons (Sonatrach 1991). The tanks were founded on a reconstituted and compacted granular fill, raised from 2 to 3 m above the natural ground level (Figure 2). The main operating load for structures is the internal pressure of the stored petroleum product. The operating loads are cyclical. For the serviceability limit state (SLS), when the tank is filled, it transmits to the floor an average stress of approximately 120 kPa.

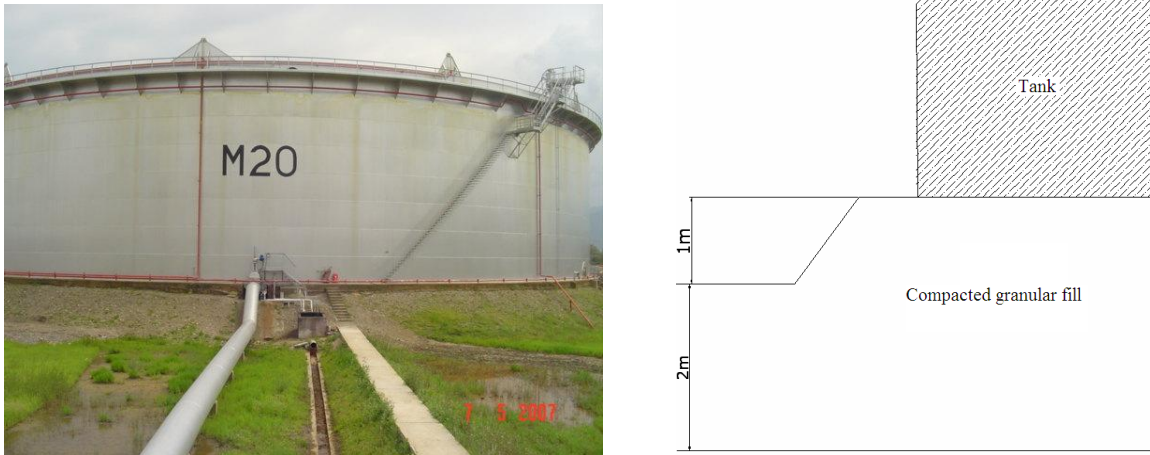
Figure 2. Oil storage tank.

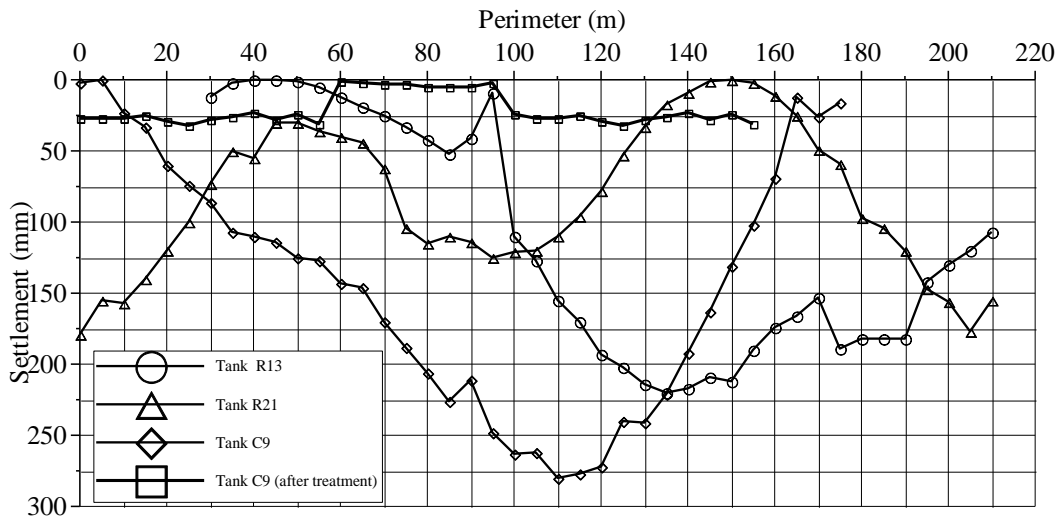
At the end of 1980s, after about 25 years of satisfactory service, three tanks C9, R13 and R21 were subjected to settlements, ovalization and tilting. The settlements observed along the perimeter of the three tanks R13, R21, and C9 are shown in Figure 3. Figure 4 shows the ovalization of the tank C9. The measured differential settlements reached maximum values of 28 cm, 22 cm and 18 cm for the tanks C9, R13 and R21 respectively (Sonatrach 2004). Because of distortion of the steel tank walls and jamming of the floating roof, a shear failure was evident and the tanks were considered unsafe for service. A comprehensive geotechnical investigation was conducted to evaluate the subsurface conditions of the site and to provide recommendations for foundation repair or retrofit of existing tanks as well as foundation design for new tanks and related facilities.

Figure 3. Settlements along the perimeter of the tanks R13, R21, and C9.

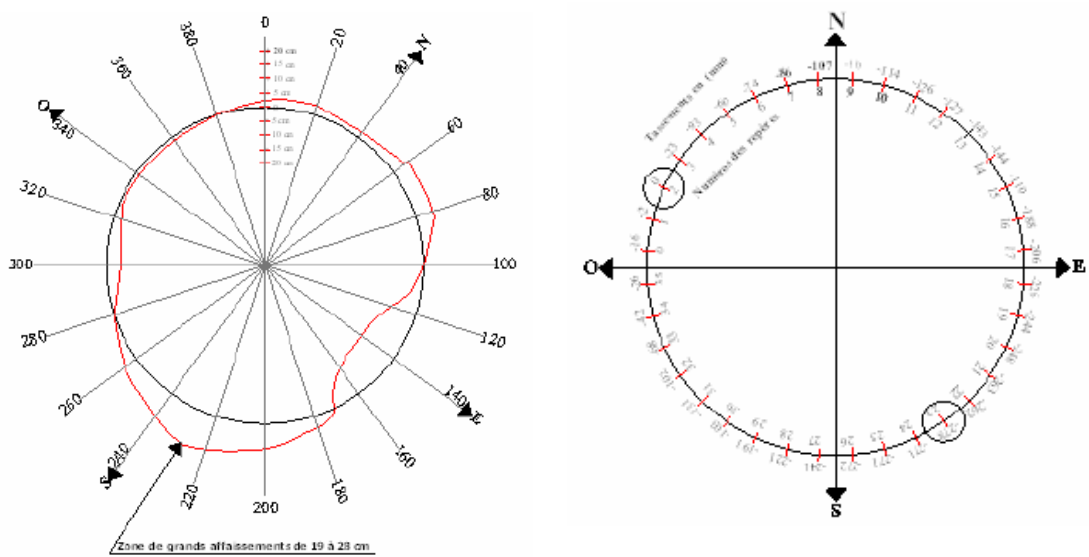
Figure 4. Ovalisation of the tank C9.

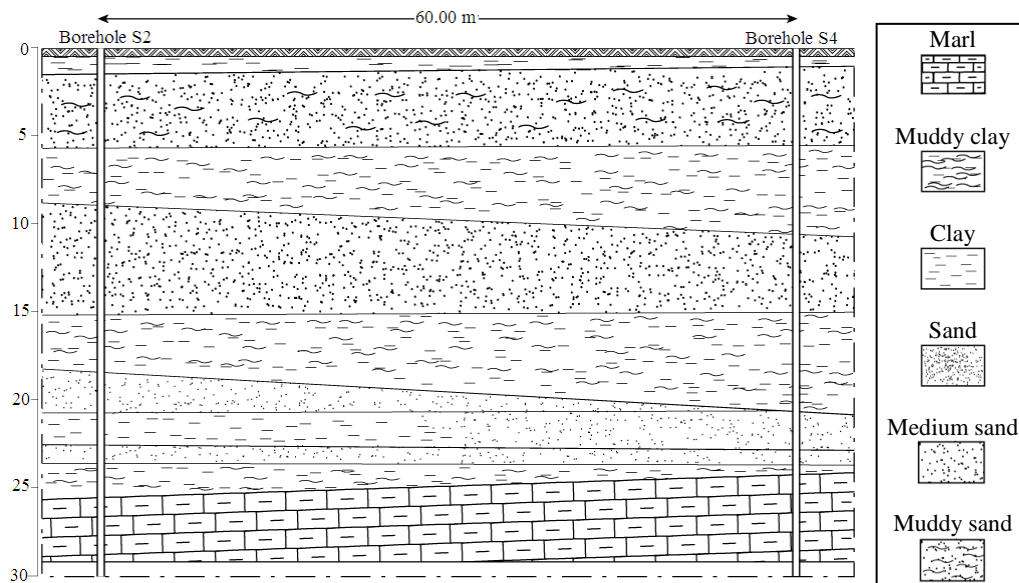
This investigation reveals that the subsoil conditions below the tank locations typically consists of 1.5 m fill overlying 24 to 28 m thick alluvial clay-sand dominated layers impregnated by mud at the northern marine terminal to sandy and gravelly with intercalation of layers of silty and muddy sand at the Southern Terminal, which is close to the marine environment. All these sedimentary layers are rest on a substratum of gray very stiff to hard marl found to a depth between 25 and 30 m. Groundwater is encountered at a depth of 2 m. Typical soil profile is shown in Figure 5. The engineering properties of the soil layers are summarized in Figure 6. This investigation indicates a low consolidation and a high compressibility of the soil layers, and shows a lateral heterogeneity of alluvial layers below the tank locations (Figure 5). This heterogeneity and the compressibility of the soft soil layers underlying the site seem to be responsible for the large differential settlements and tilting experienced by these tanks.

Figure 5 : Typical soil profile.

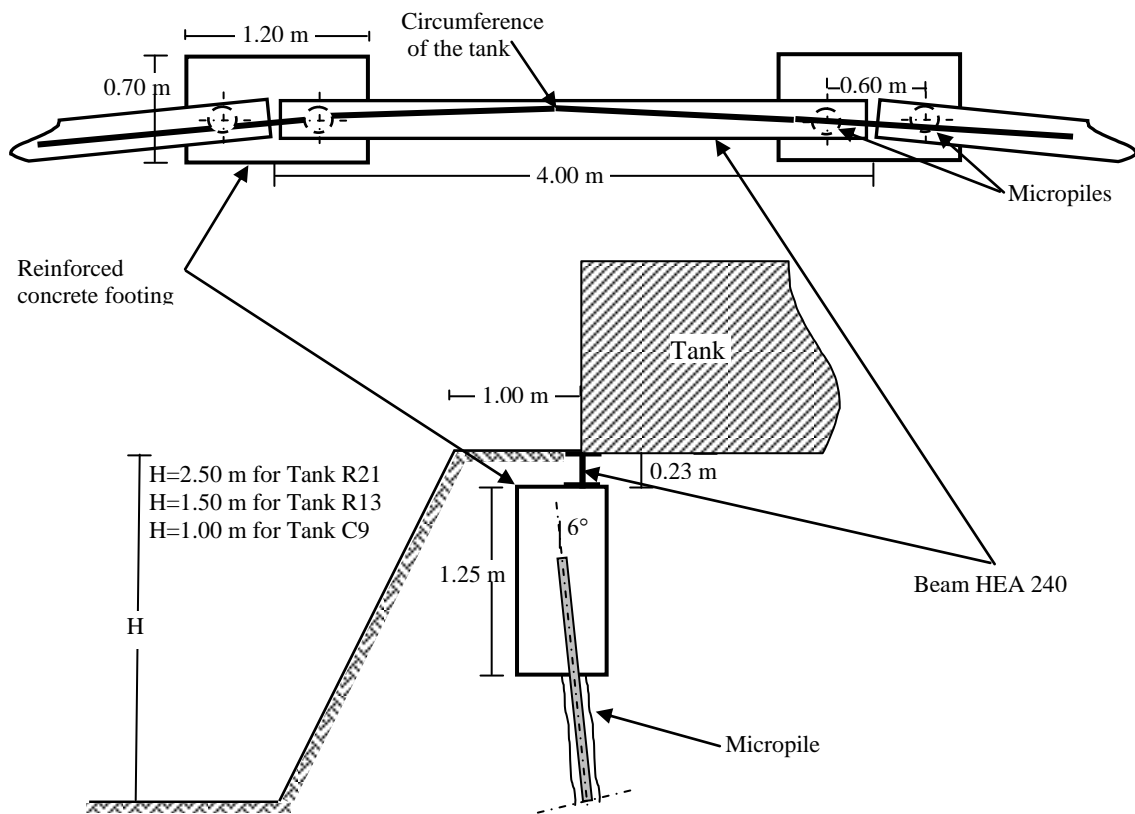
Figure 7. Strengthening and underpinning work.

Based on the geotechnical investigation results, it was concluded that the subsurface soils underneath each tank to be improved. Micropiling has been chosen to strengthen the soil beneath the foundation (Figure 7). For some tanks, strengthening and underpinning work at site started in 1992, and ended in 2000. The superstructure was restored by jacking it up to the required elevations.

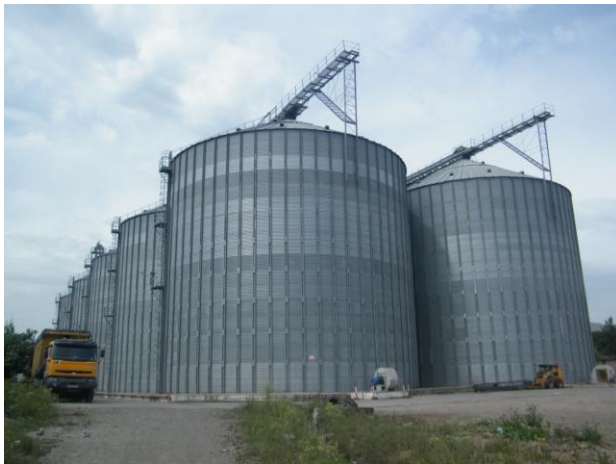
The structure consists of a battery of ten cylindrical steel silos for grain storage with a total capacity of 76000 tons (Figure 8). The height of each silo is 27 m and the diameter 23 m. The silos are based on a large flexible raft foundation of reinforced concrete of rectangular shape of 75 cm thick and 120x50 m² area. The geotechnical investigation shows a succession of sedimentary layers of silt and muddy silty sand up to 30 m depth, and then comes below a layer of plastic marl sometimes muddy (Figure 9). The level of the water table is detected from 2 m in depth. The superficial layer of site through the first twelve meters is characterized by a void ratio variable 1.06 to 1.30 and a compressibility index C_c varying between 0.37 and 0.54. These results reflect the very loose nature of the soil and high compressibility. The dynamic penetrometer tests showed a horizontal homogeneity of alluvial formation (Figure 10). The minimum value of resistance is recorded from 0.8 to 1.0 MPa on the first twelve meters. The dynamic resistance of the layer of fine dense sand is found higher than 10 MPa at 12 m depth. For a large raft foundation, the oedometer method was used to estimate the settlement. For a service stress of 120 kPa, compaction consolidation of alluvial layers of 40 m depth is estimated at 160 cm. These results are not allowable. Therefore, there is need to move into the deep foundation system or to proceed to reinforce the soil.

Figure 8. View of the silos.

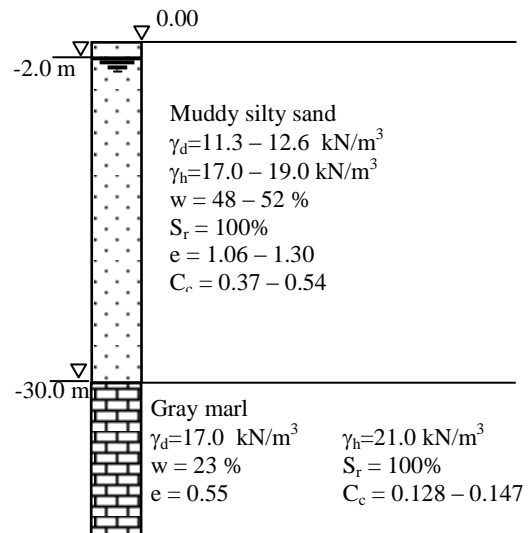
Figure 9. Geotechnical profile.

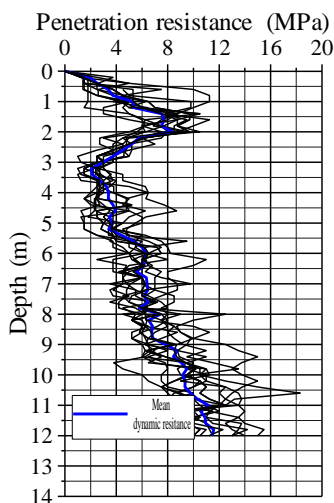
Figure 10. Dynamic penetration test results

Based on the results of dynamic penetrometer test and the experience already gained in previous projects made at the harbor zone of Bejaia makes the contracting authority and the owner of the work to strengthen soil by stone columns (Coprec 2004). This choice is also justified by the cost of achieving in comparison to deep foundations by piles, the local availability of substitute material (ballast) and timeliness of the process. The final depth of treatment was selected on the basis of the control tests without any theoretical justification. The large raft is anchored on 12 m reinforced soil by stone columns (Figure 11). The stone columns have an average diameter of 1 m and a length of 12 m. The diameter of 1 m was verified after stripping of the column test conducted near the site. The mesh really made in the field is regular and rectangular, 2.39m x 2.43m. These dimensions represent respectively the space between the stone columns in the transverse and longitudinal

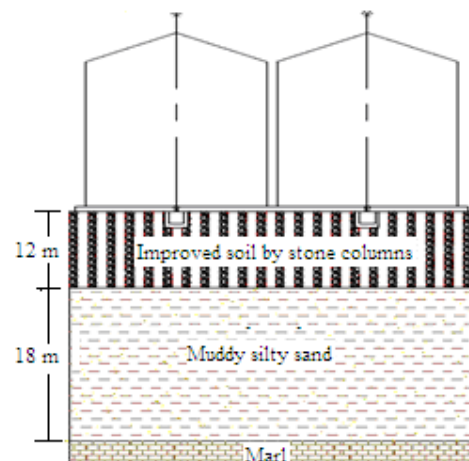
Figure 11. Schematic section.

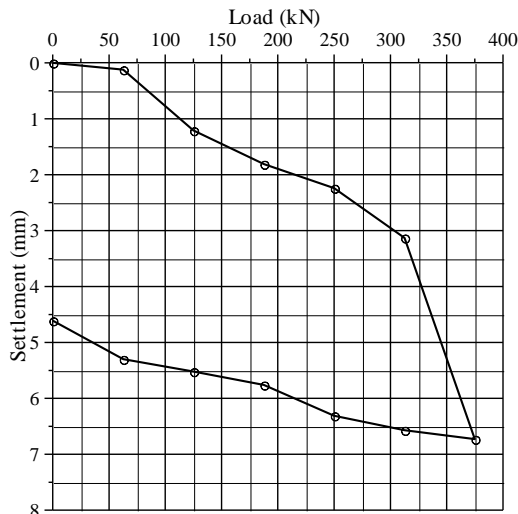
For verification of the design and certification of stability and serviceability, a load test on a single stone column was performed according to standards by the company responsible for carrying out the work. The load settlement behaviour of the improved ground as observed for single column tests is presented in Figure 12. The results give a settlement of about 7 mm for 1.5 time ultimate state limit, corresponding to 478 kPa. Twenty dynamic penetrometer tests were also carried out on stone columns in order to determine their mechanical properties according to the requirements of the DTU 13-2 (1978) and COPREC (2004). Typical results are given in Figure 13. These results showed that only 25% of tests give a dynamic resistance greater than 15 MPa from 1 m depth. 75% of tests give dynamic resistance between 3 and 9 MPa from 2 to 4 m depth. The work began in 2004 and completed in early 2005. A monitoring system of settlement was placed on the silos.

Figure 12. Results of a single stone column load test.

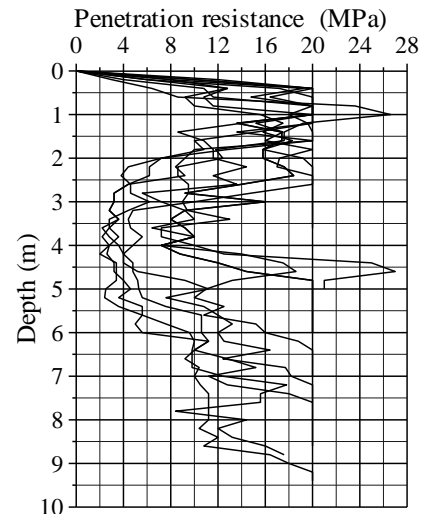
Figure 13. Typical dynamic penetration resistance results carried out on stone column

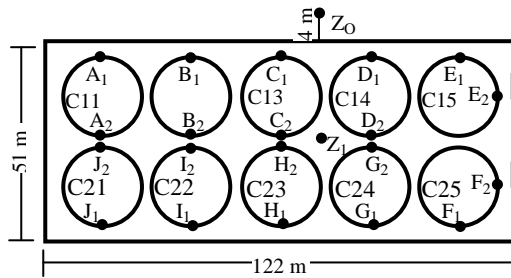
For verification of the design and the stability of the silos during the cereal storage, the structure was monitored to evaluate vertical settlements. The settlements were made by tachometric aiming on twenty fixed reflective targets (points A1, B1,..., Figure 14). Four stations were installed sufficiently far from the silos to avoid the influence of the loading of the silos and vibration devices. They were fixed on reinforced concrete caissons isolated by polystyrene to avoid possible relative movements of the stations. The reflectors were fixed on both outer edges and central part of the silos to the same initial side elevation. The measures are conducted in accordance with the general loading and unloading of the silos. The observations were made from 01/09/2005 to 01/03/2007. Two independent stations, Z_0 and Z_1 are also located respectively outside and on the center of the raft.

Figure 14. Layout of the silos.

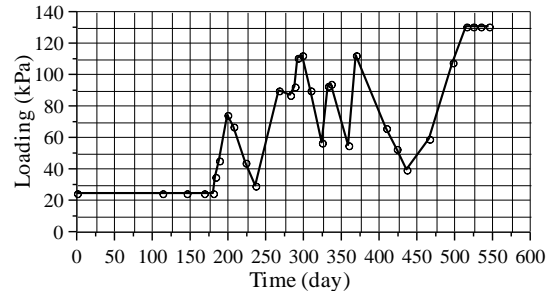
Figure 15 shows a typical loading and unloading of the silos in time recorded on 545 days of assessment. The distribution of foundation settlements in time for some measuring points is shown in Figure 15. Figure 16 shows the settlements against the silo load on the center of the raft. The analysis of the different results obtained has the following observations:

Figure 15. Loading of the silos since 01/09/2005.

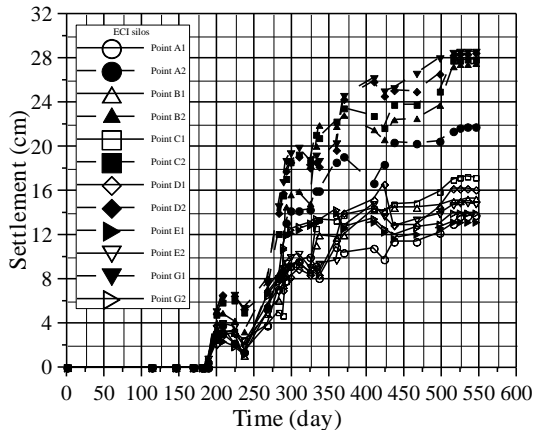
- During the first five months of loading and unloading of the silos, the foundation settlements developed rapidly to about 15 to 20 cm and 7 to 13 cm on the center and the edges of the raft respectively. The maximum differential settlement is 10.80 cm which is measured in the silo C23. The differential settlement occurred is prejudicial to the stability of the structure that the first signs of tilting and deformations at the base of the silos began to appear at the central area.

- The loading evolution to a value of 130 kPa and maintained constant during one month generated a total settlement of 28 cm in the central area and 17 cm at the edges. The differential settlement is about 11 to 14 cm between center and periphery of the raft. The differential settlement was accentuated by the non compliance with recommendations for loading and unloading silos.

- The indices of excessive settlements appear on site by observed deflection of the raft, the change of the slope of the cover raft toward the central part, important deflection of the road, cracks and tilting of the silos particularly the silos C13, C14, C23 and C24.

- The soil improvement has done only under the raft; it was arrested at the edge of the raft. The difference in behavior between the two areas, virgin soil (outwards of the raft) and improvement soil (under of the raft) supported the development of the differential settlements. The measured settlement at point Z_0 located at 4 m from the edge of the raft is about 7 cm.

Figure 16. Settlements from 01/09/2005 to 01/03/2007

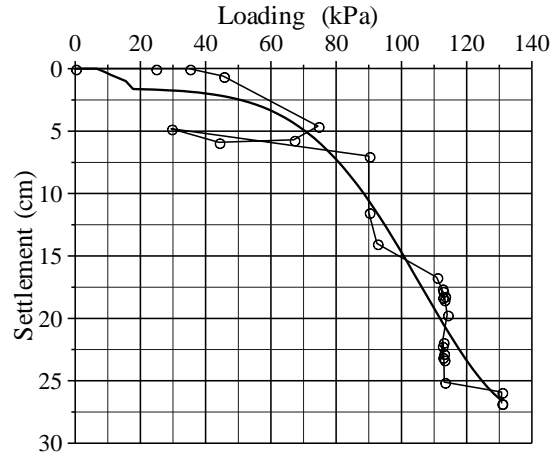
- The maximum total settlement measured at the center of the raft is 28 cm. This result is obtained for loading varying from 24.60 to 130 kPa. The settlement tends to stabilize because it is stationary for a month of observation with a constant loading. However, regarding to floating stone columns, it is necessary to understand the consolidation settlement of compressible layer that lies between the base of the stone columns and the marl bedrock (18 to 23 m thick). The settlement obtained by the method of Priebe for a stress of 130 kPa is 58.30 cm, with 14.60 cm obtained in the treated layer. This result seems reasonable owing to the fact that the in-depth influence of the raft foundation and a settlement of untreated layer will appear in the long term.

Figure 17. Settlements vs. loading at the raft center.
